# CARPINTERIA CREEK WATERSHED

POST FIRE ASSESSMENT - PROJECT REPORT FINAL - GRANT AGREEMENT #D1813302

March 29, 2019

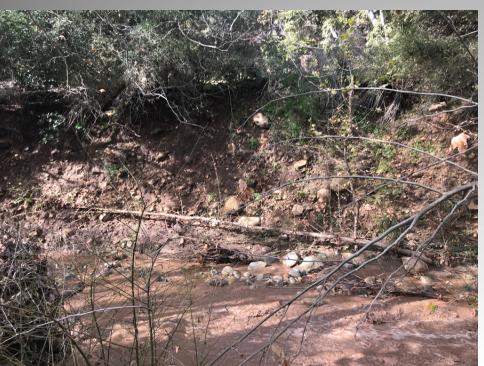
**Project Name:** Cate School Bank Protection Project

**Status:** Recommended in 2005 Watershed Plan; Implemented but flood damage identified

**Recommendation:** Replace and rearrange some boulders near toe of slope to replace protection lost during debris flows

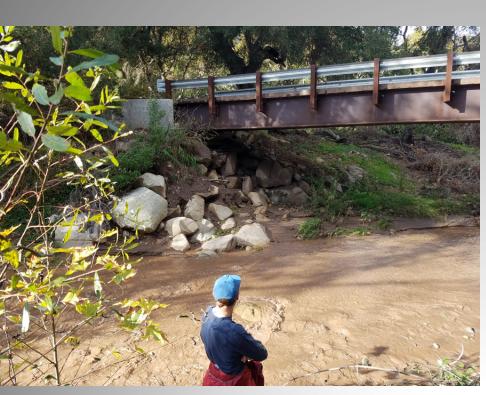
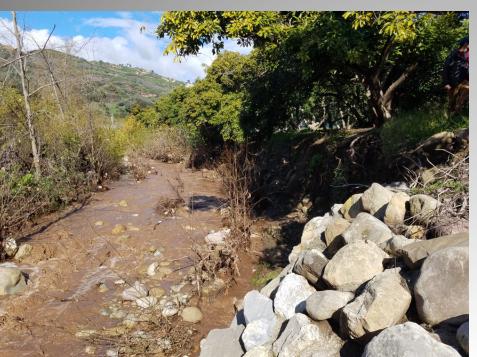
**Project Name:** Bankline Improvements below Circle G Bridge

**Status:** Recommended in 2005 Watershed Plan; Implemented but flood damage identified

**Recommendation:** Replace and rearrange boulders near toe of slope to replace protection lost during debris flows

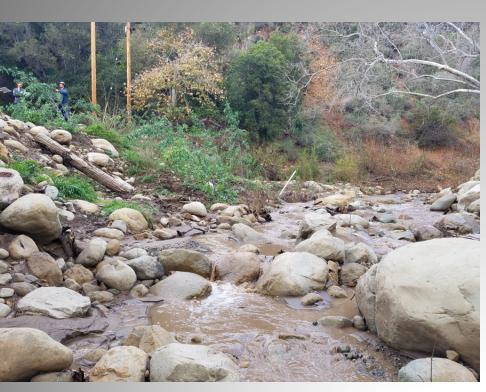
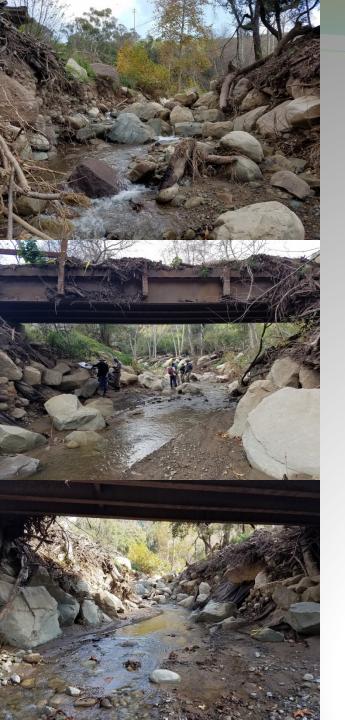
**Project Name:** Widdoes Crossing Improvements

**Status:** Recommended in 2005 Watershed Plan; Implemented but flood damage identified

**Recommendation:** Lay back bank upstream of Widdoes bridge; replace abutment toe protection

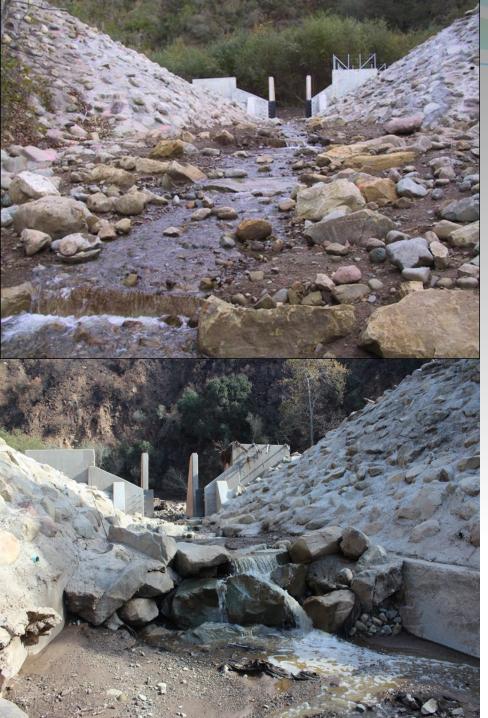
**Project Name:** Gobernador Debris Basin Fish Passage

**Status:** Identified by Santa Barbara County; Implemented but flood damage identified

**Recommendation:** Construct roughened channel to replaced grouted rock weirs

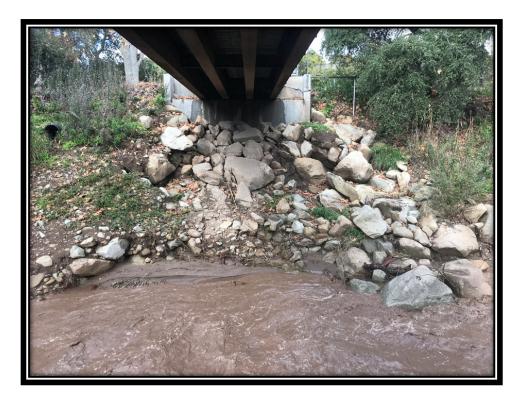
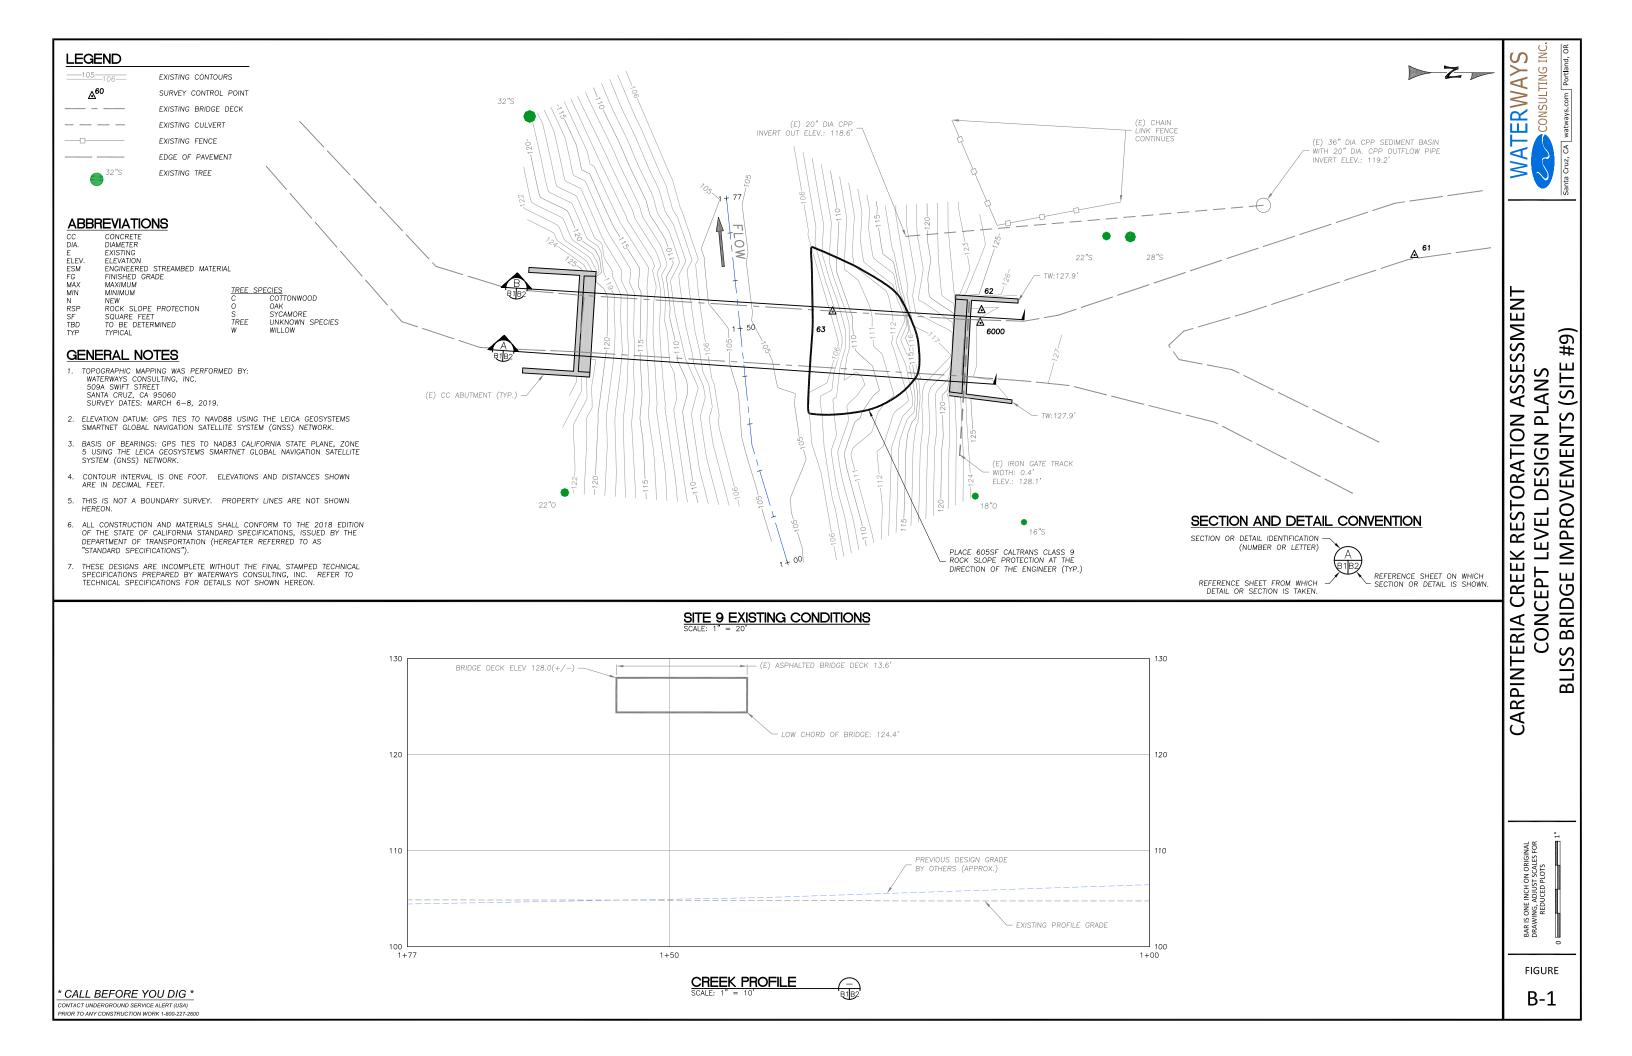
#### CARPINTERIA POST FIRE ASSESSMENT- SITE 9 BLISS BRIDGE IMPROVEMENTS CONCEPT DESIGN SUBMITTAL

The overall impact to the Bliss Bridge due to the post-Thomas fire flood and debris flow was minimal. No damage occurred to the bridge or the abutments and the bridge had adequate capacity to covey the high flow event. The impacts were confined to mobilization of some of the 1 to 2-ton RSP along the base of the right abutment (see photo). The proposed repair at this site consists of reconstructing the right bank RSP slope under the bridge to ensure long-term protection of the abutment and steel piles. Site access will likely be achieved along the right bank, just downstream of the bridge. The site will be revegetated with native riparian species following construction.

The Bliss Crossing is located on the mainstem of Carpinteria Creek, just downstream of the Casitas Pass Road crossing. Historically the site consisted of a concrete ford crossing and associated grouted rock structure that blocked fish passage. The ford crossing was replaced in 2008 with a freespan bridge structure and the channel was reconstructed to facilitate fish passage and stabilize the creek channel. The bridge abutments consist of shallow concrete footings with embedded steel pile and pile cap. The bridge abutments were protected with 1 to 2-ton Rock Slope Protection (RSP) installed at a slope of 1.75:1, extending below the finished bed elevation of the reconstructed channel.

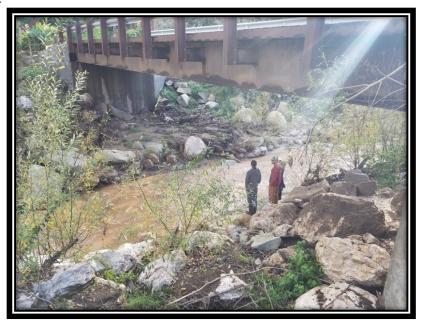
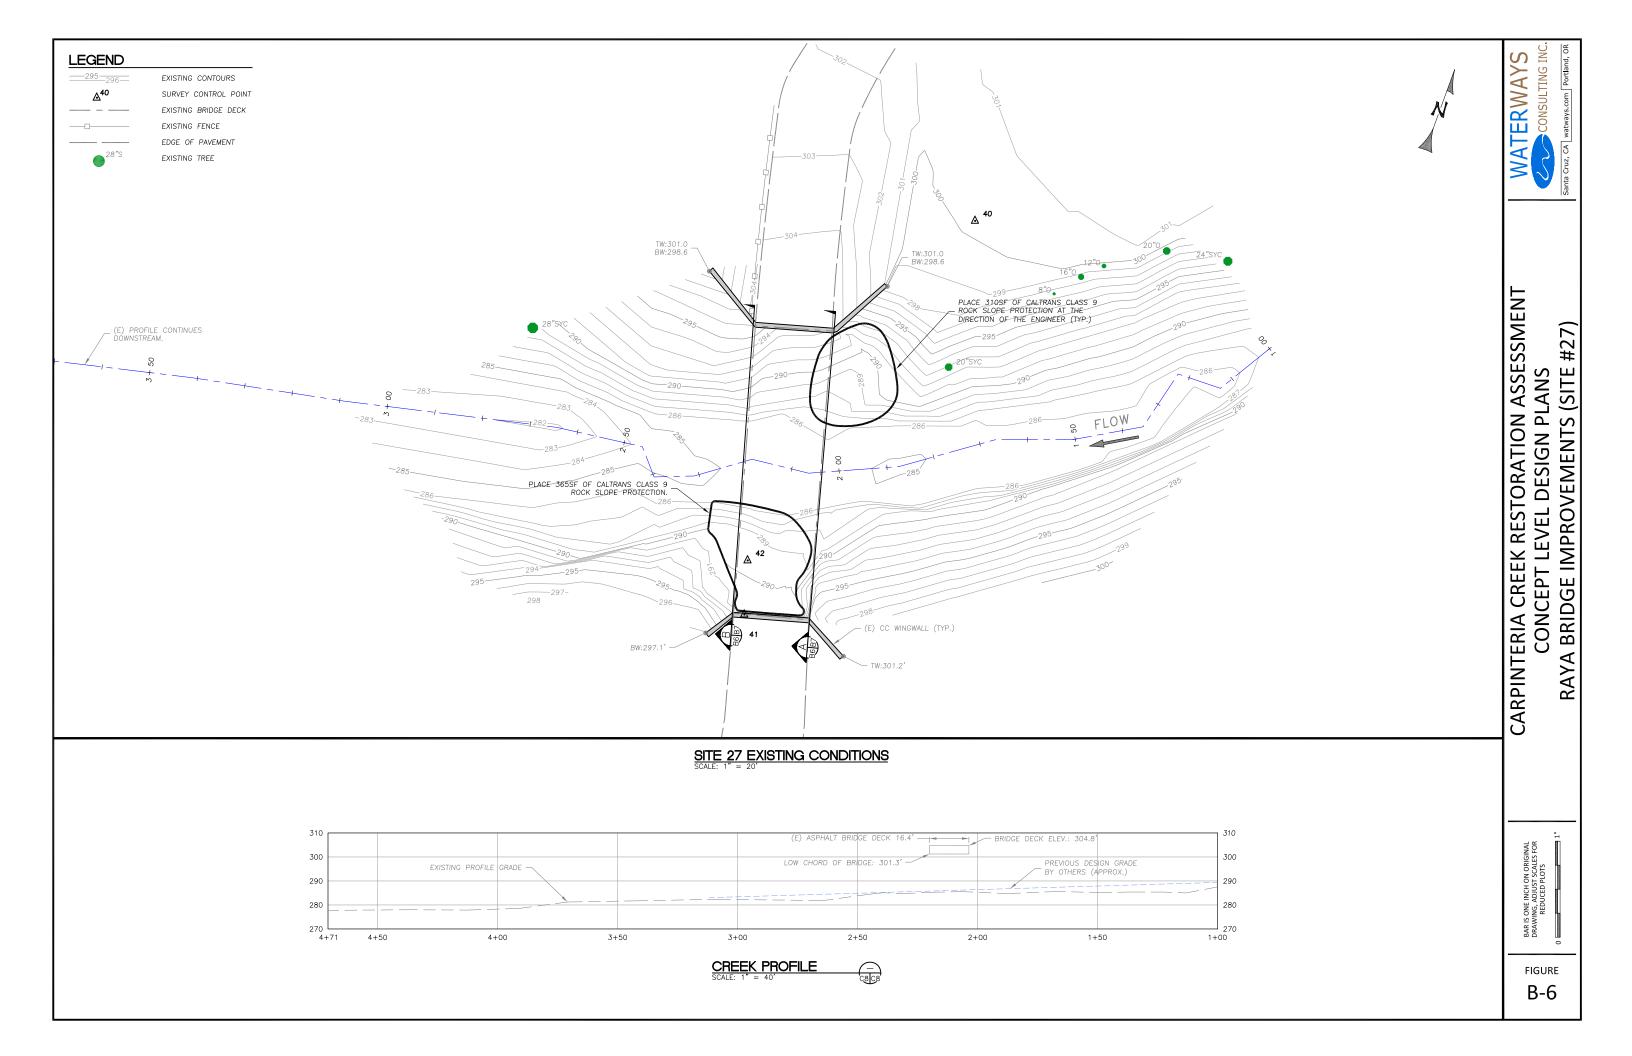
## CARPINTERIA POST FIRE ASSESSMENT- SITE 27 RAYA BRIDGE IMPROVEMENTS CONCEPT DESIGN SUBMITTAL

The overall impact to the Raya Bridge due to the post-Thomas fire flood and debris flow was moderate. The bridge was slightly overtopped by the high flow event though there was only minimal damage to the upstream railings. The primary impacts were to the 2-ton RSP along both banks, with the most significant impact occurring along the left bank where most of the RSP was washed away, exposing the retaining wall (see photo). On the right bank, some RSP was mobilized at the upstream side of the bridge, though it appears that the impact was surficial and could easily be repaired. The proposed repair at this site consists of reconstructing the left bank RSP slope under the bridge to ensure long-term protection of the abutment and retaining wall. Along the right bank, the repair consists of replacing the mobilized RSP rather than reconstructing the entire slope. Site access will likely be achieved along the left bank, just upstream of the bridge. The site will be revegetated with native riparian species following construction.
