# CARPINTERIA CREEK WATERSHED

POST FIRE ASSESSMENT - PROJECT REPORT FINAL - GRANT AGREEMENT #D1813302

March 29, 2019

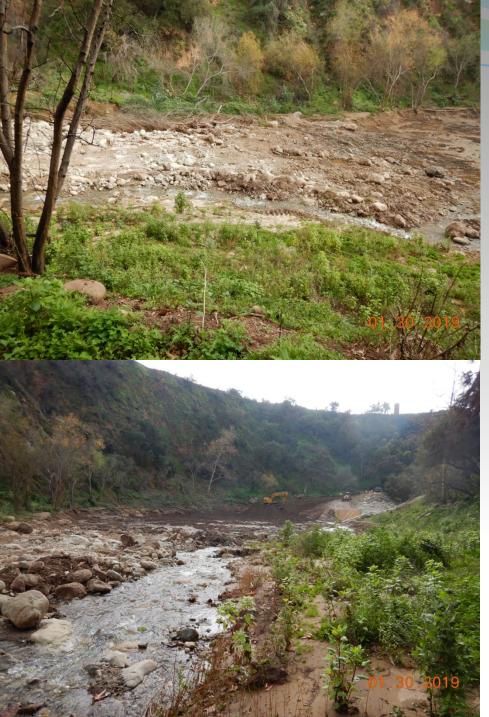
**Status:** Identified by Santa Barbara County; Implemented but flood damage identified

**Recommendation:** Construct roughened channel to replaced grouted rock weirs

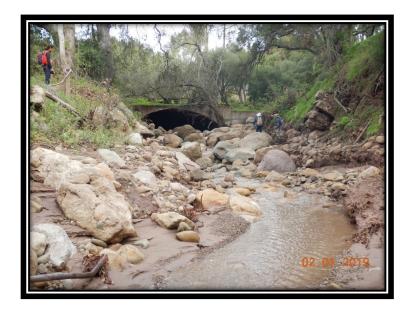
Lillingston Canyon Road crosses the mainstem of Carpinteria Creek just upstream of the confluence with Gobernador Creek. Based on the post-Thomas fire geomorphic assessment it appears that the boulder-laden debris flow that affected Upper Carpinteria Creek stopped at the base of the mountain front in the vicinity of the Lillingston Canyon crossing. Large boulders were deposited in the short reach between the Lillingston Canyon Road crossing and Gobernador Creek confluence, creating a series of cascades that was determined to be impeding fish passage, significantly reduced the conveyance capacity of the culvert, and is causing erosion of the adjacent streambanks and hillslopes as Carpinteria Creek cuts around the deposited boulders (see photo). One potential explanation of why the boulders deposited in this location is that high flow in Gobernador Creek reached the confluence faster than flows on Carpinteria Creek, resulting in backwatering at the confluence that extended a considerably distance upstream, reducing the water surface slope on Carpinteria Creek and halting the propagation of the debris flow. Deposition upstream of the confluence and through the culvert ultimately caused floodwaters to overtop the crossing and flow along Lillingston Canyon Road.

The proposed project at this site would consist of reorienting the deposited boulders to create a fish passable channel along the center of the valley bottom and placing the deposited boulders along the toe of the slopes to limit additional lateral migration of the channel and erosion of the streambanks and adjacent hillslope. Additional investigation of the depth of the culvert footings will need to be completed during the design phase to determine an appropriate slope for the channel. Access to the site will be obtained along the left bank, downstream of the crossing near the entrance to the Cate School.

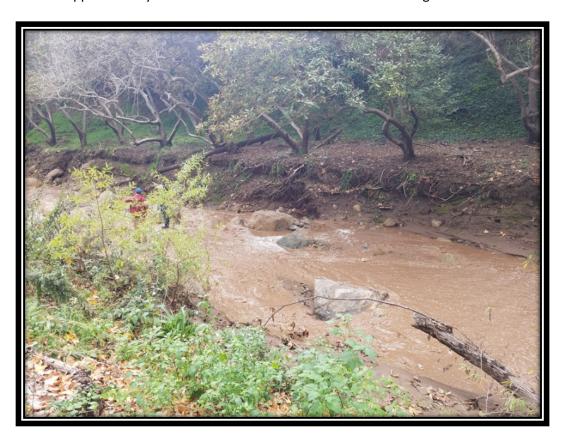
This site is located approximately 500 feet upstream of the Lillingston Road crossing on property owned by the Cate School. The site consists of a steep eroding right bank lined with two rows of mature avocado trees along a narrow, historic floodplain bench (see photo). In discussion with Cate School administrators, the two rows of avocados are not productive and are difficult to access given their location. The would either need to be rehabilitating and removed/replaced to make them viable. Consequently, they have expressed interest in this project and support enhancement/restoration of Carpinteria Creek.

The proposed project would consist of removing the avocado trees from the historic floodplain terrace, laying the steep, eroding slope back at a 3:1 slope, and replanting the site laid back bank, terrace and adjacent hillslope with native riparian species. In addition, there may be opportunities on the left bank to plant some additional riparian vegetation in discrete areas that are not already vegetated, to create a continuous corridor of native riparian through this reach of channel. Approximately 200 feet of bank would be laid back and revegetated.
